GAM FW Upgrade Procedure

October 20, 2023

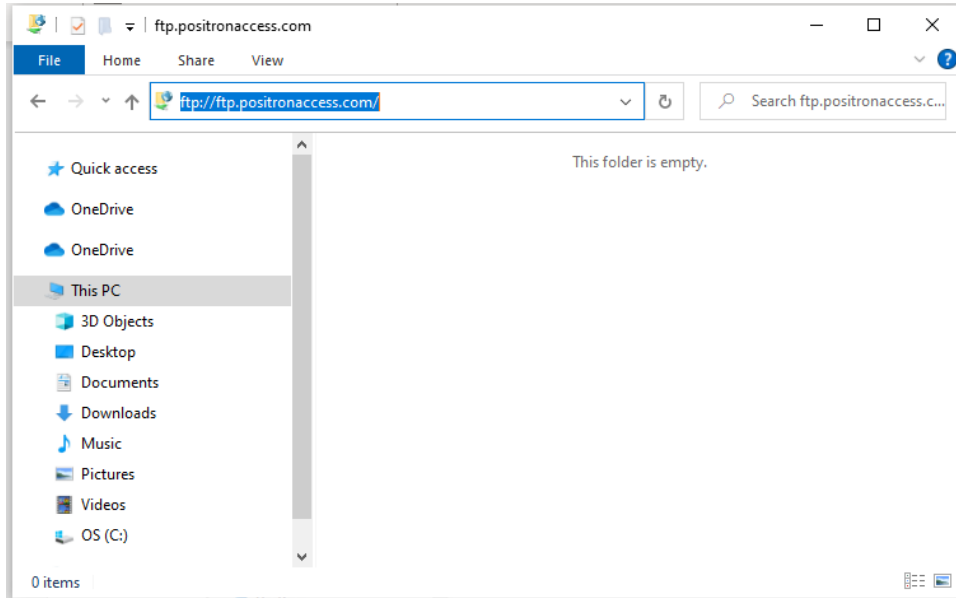
1. Use windows File Explorer app or a FTP client like Filezilla to open connection with Positron FTP Server with link shown below.

Figure 1 Connecting with Positron FTP Server using File Explorer

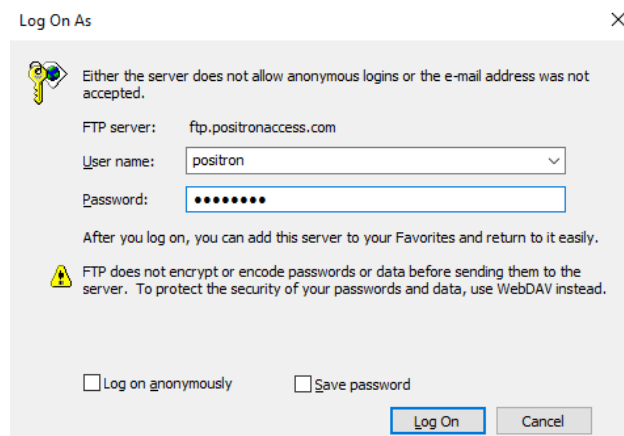
2. Once the Log On window be prompted, use the following credentials:

Figure 2 FTP Log On window

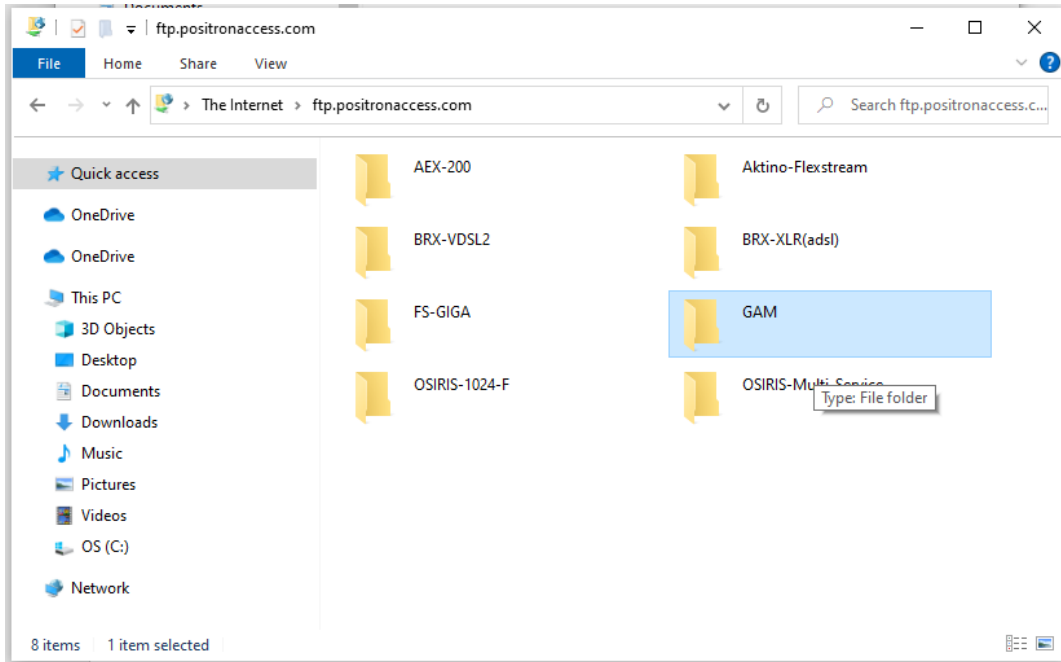
3. Select **GAM** folder and open it by double clicking on it.

Figure 3 GAM folder in Positron FTP Server

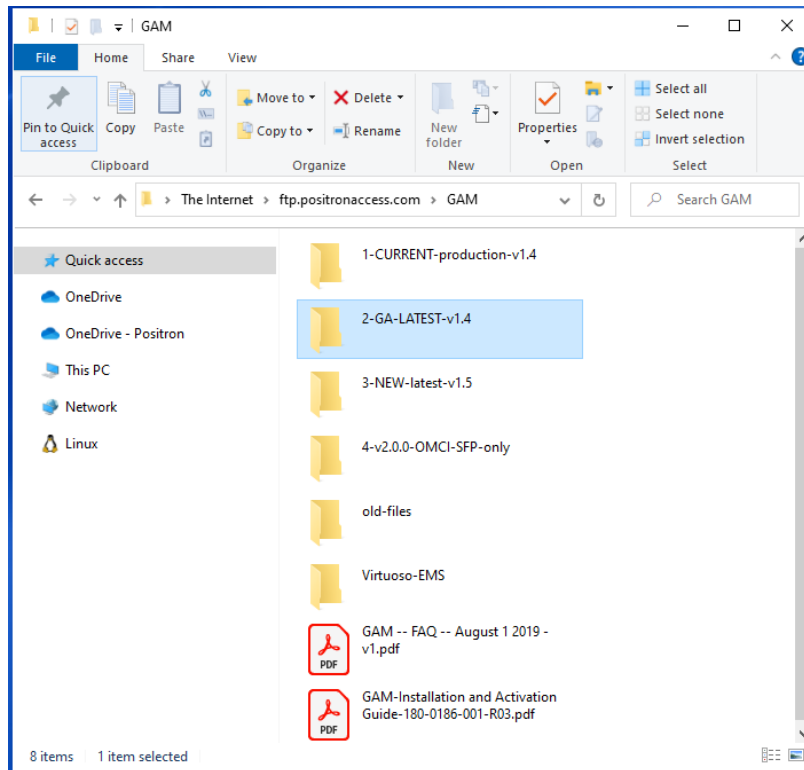
4. For GAM working with G1000 Endpoint series only go to folder **2-GA-LATEST-v1.4**. before going to higher versions (see **Figure 4**). Read **IMPORTANT NOTES A AND B ON PAGES 5 AND 7**

Figure 4 Folder with FW for GAM working with G1000

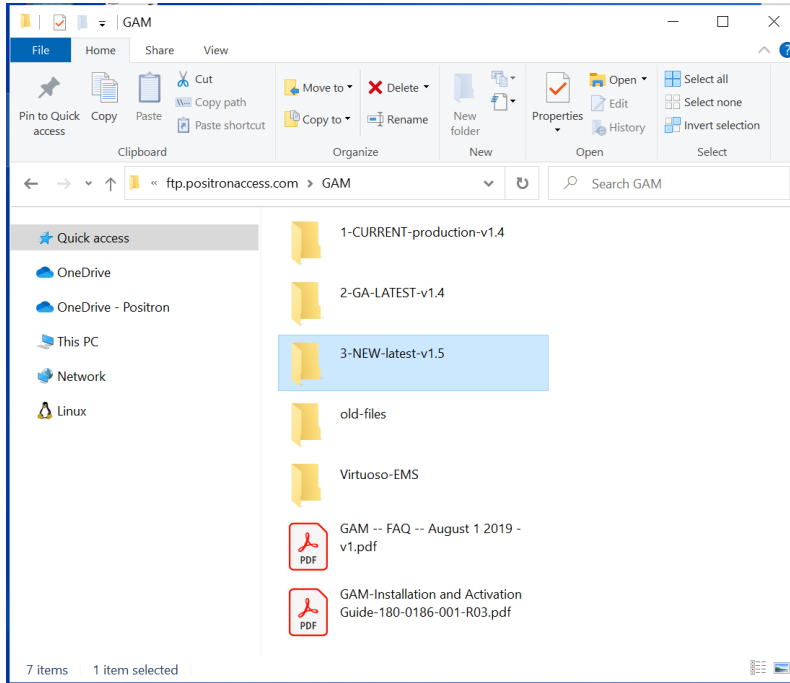
- For GAM working with G1001 and G1002 Endpoint series go to folder **3-NEW-latest-v1.5** (see **Figure 5**)

Figure 5 Folder with FW for GAM working with G1001/G1002

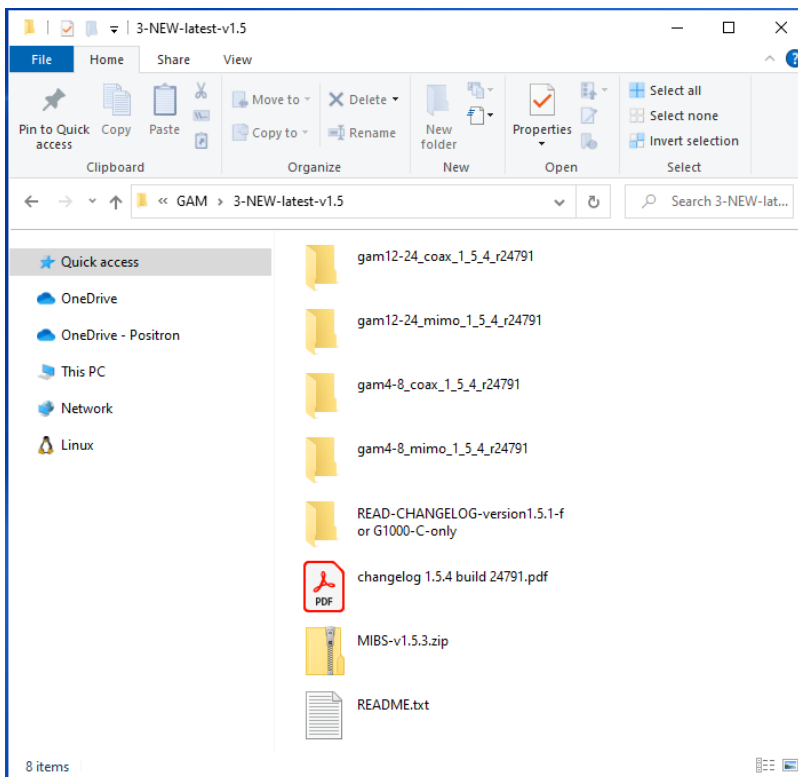
- Each GAM type, indoor/outdoor/MIMO/Coax has a different folder. (see **Figure 6**),

Figure 6 Folders with FW for different models of GAM

- a. gam12-24_coax_1_X_X_r2XXXX is for Indoor **GAM-12-C** or **GAM-24-C**
 - b. gam12-24_mimo_1_X_X_r2XXXX is for Indoor **GAM-12-M** or **GAM-24-M**
 - c. gam4-8_coax_1_X_X_r2XXXX is for Outdoor **GAM-4-CX** or **GAM-4-CRX**
 - d. gam4-8_mimo_1_X_X_r2XXXX is for Outdoor **GAM-4-MX** , **GAM-8-MX**, **GAM-4-MRX** or **GAM-8-MRX**
7. Once you locate the right folder, open it and proceed to download the file with “.mfip” extension into your PC, see **Figure 7**. For Example: for a GAM12/24-M the file will be ftp://ftp.positronaccess.com/GAM/3-NEW-latest-v1.5/gam12-24_mimo_1_5_4_r24791/

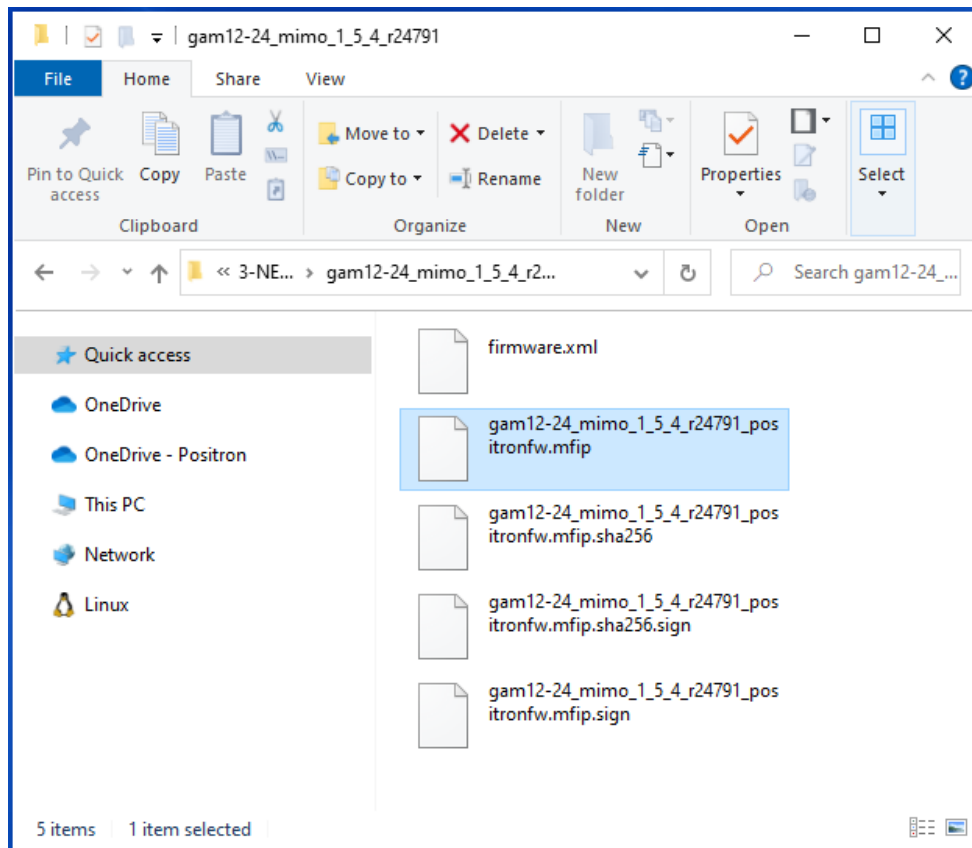
Figure 7 Firmware load for GAM 12/24-M working with G1001/G1002 series

The GAM doesn't validate if you are using the proper file for the GAM model, validation was implemented from V 1.5.0.r22842, it is important to upload the good file if you are running an older version.

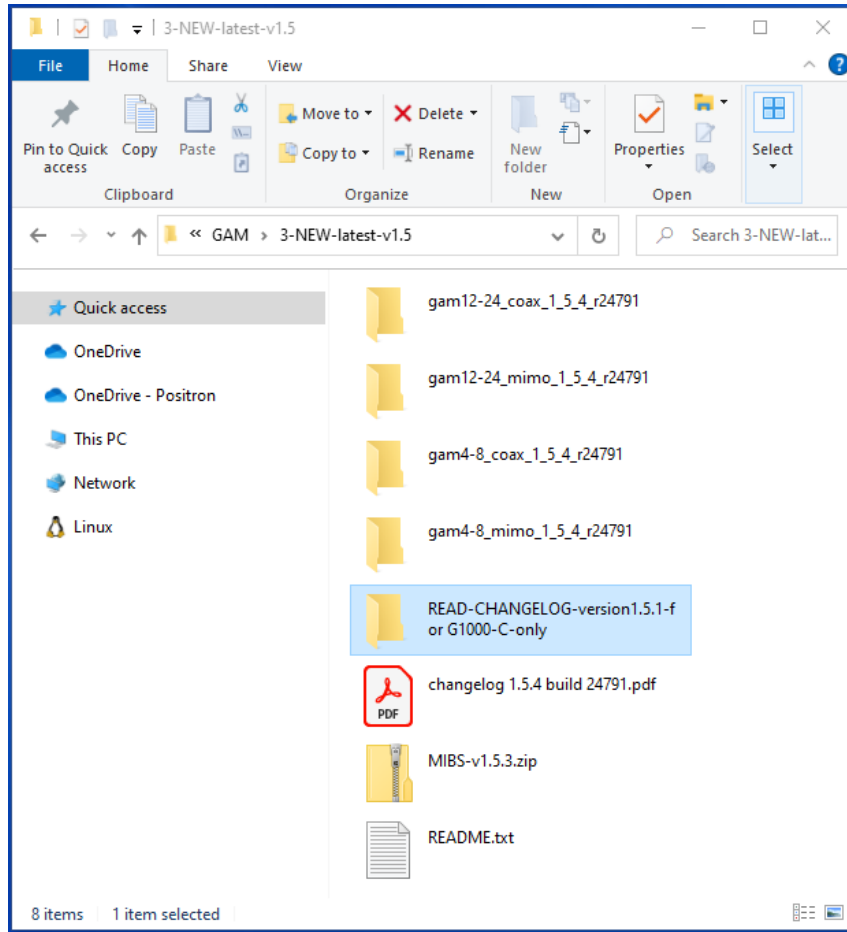
- A. IF YOU ARE RUNNING A VERSION PRIOR OF 1.5.1 AND HAVE LEGACY G1000-C (COAX ONLY) IN YOUR NETWORK, YOU MUST UPGRADE TO V1.5.1 PRIOR TO UPGRADE TO 1.5.4, IF NOT, YOU WILL BE STUCK WITH ENDPOINTS THAT WILL NEVER UPGRADE. VERSION 1.5.1 IS LOCATED IN <ftp://ftp.positronaccess.com/GAM/3-NEW-latest-v1.5/> AS SHOWN IN **Figure 8** and **Figure 9****

Figure 8 Folder with GAM FW V 1.5.1

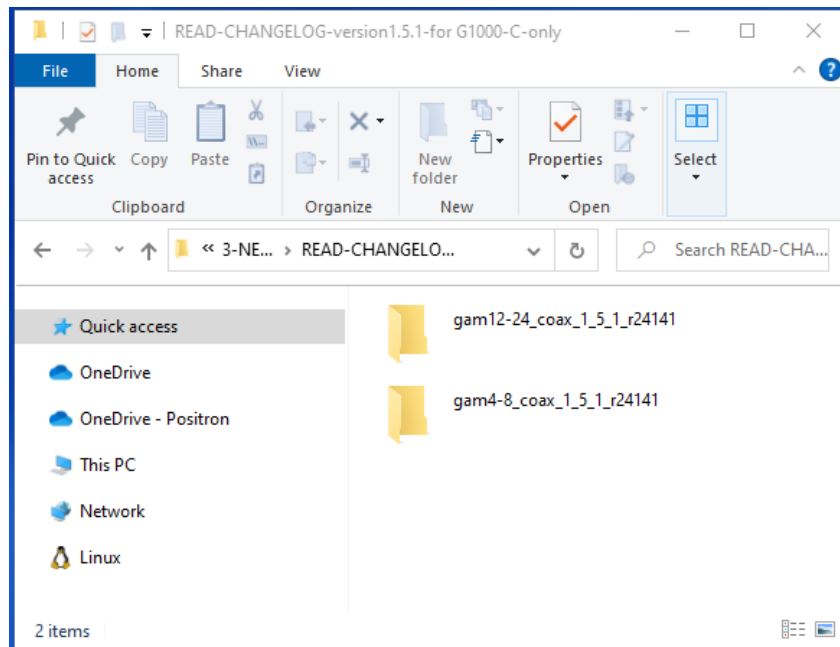
Figure 9 Folders with FW V 1.5.1 for Coax GAM

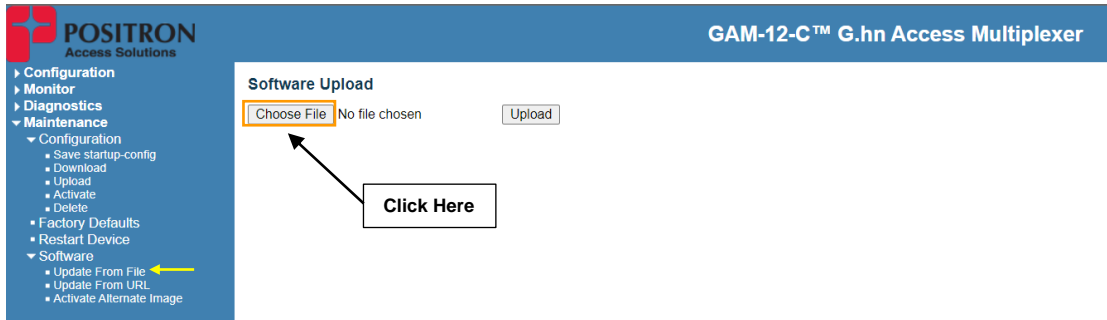
11. Under **Maintenance**→**Software** select **Update From File** See **Figure 11**.
12. Click on **Choose File** button to locate the **.mfip** file downloaded previously in your PC then press **Open** button to confirm, see **Figure 12**.
13. Click on **Upload** button to start the update process, see **Figure 13**.

Figure 11 Update From File menu

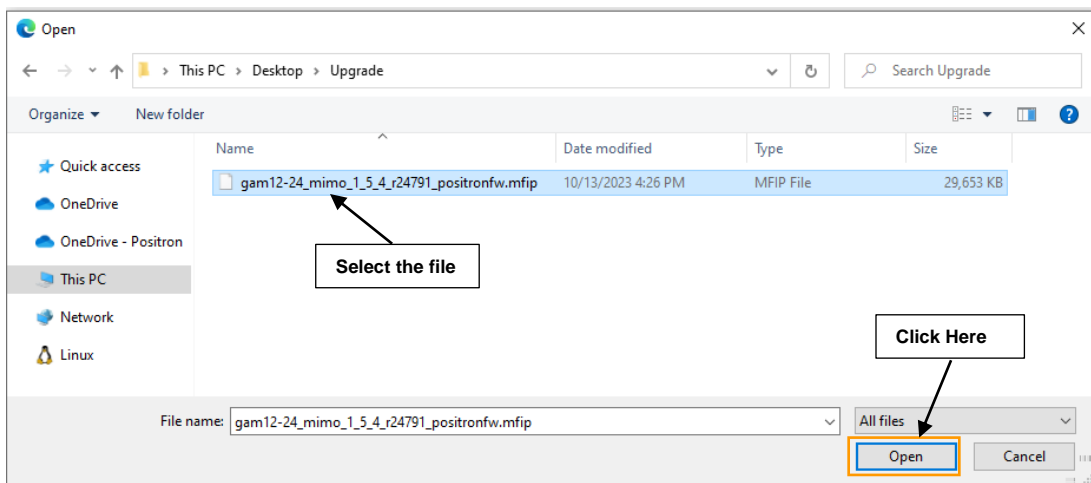
Figure 12 Selecting new GAM Firmware

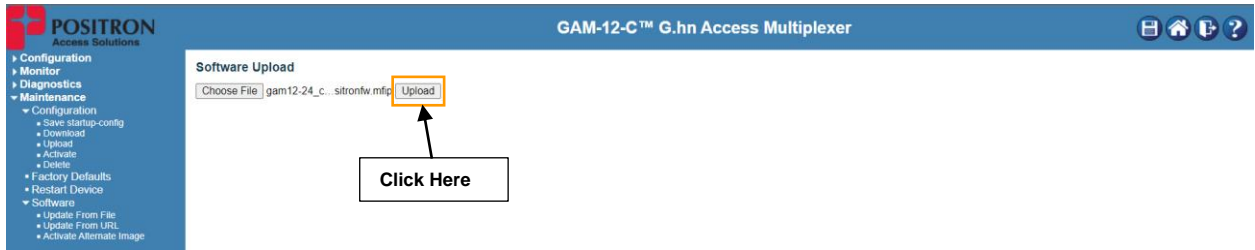
Figure 13 Starting Update Process

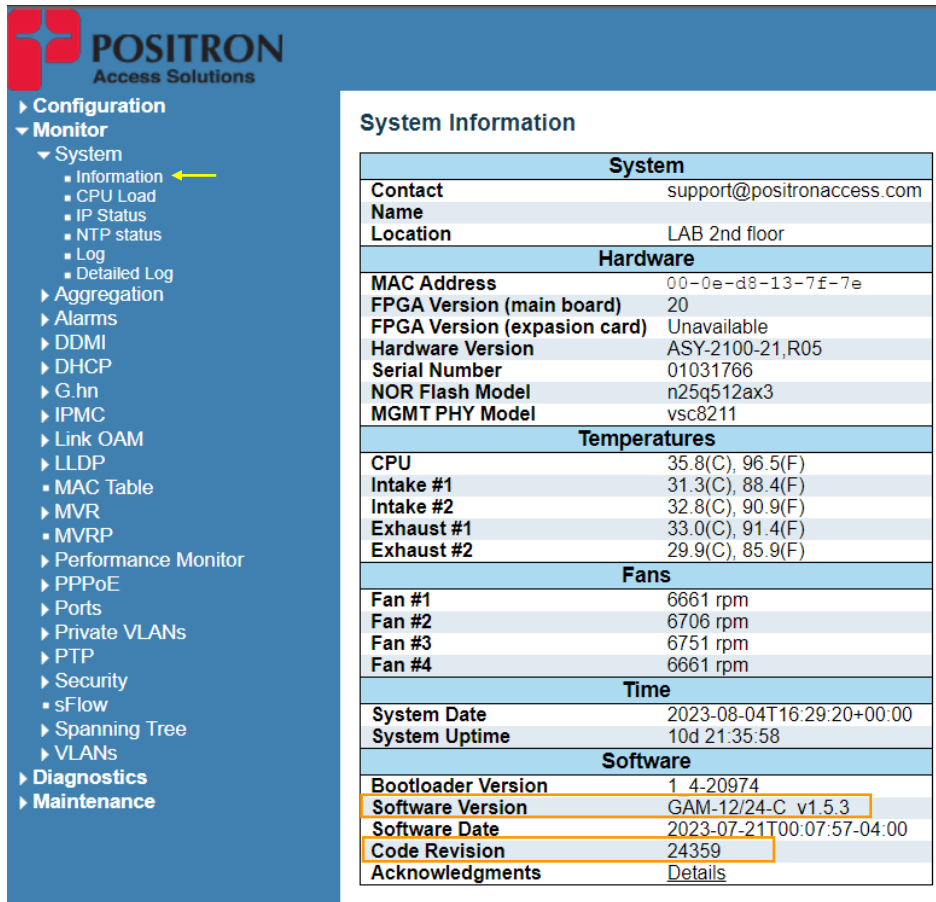
14. It will take a few minutes and the system will reboot the GAM automatically once the firmware load is copied into the flash. (Upgrade takes around 5-10 mins)
15. After the GAM upgrade is completed, a message will appear in Web GUI confirming it.
16. Go to **Monitor**→**System**→**Information** to confirm that the GAM is working with new firmware version and release, see **Figure 14**.

Figure 14 Checking new gam FW version

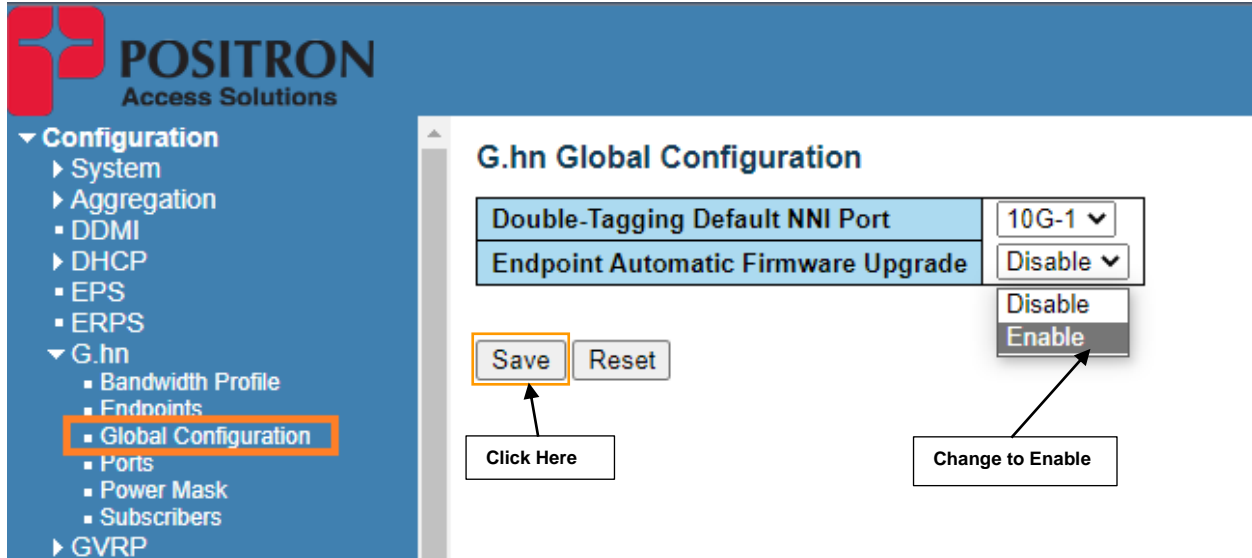
18. Upgrade of endpoints firmware can be done manually one by one by clicking on the MAC address of endpoint while in **Monitor→G.Hn→Overview**, a button “**upgrade endpoint**” should be available to proceed (~1min to upgrade each). There is an option to perform automatic firmware upgrade of the endpoint as shown in **Figure 15**.

Figure 15 Enabling Endpoint Automatic Firmware Upgrade
